A1	Trouble-shooting program	↓
-----------	--------------------------	---

1. Special features

This microcard deals with the VW vehicle models with breakerless transistorized ignition (TI-H)

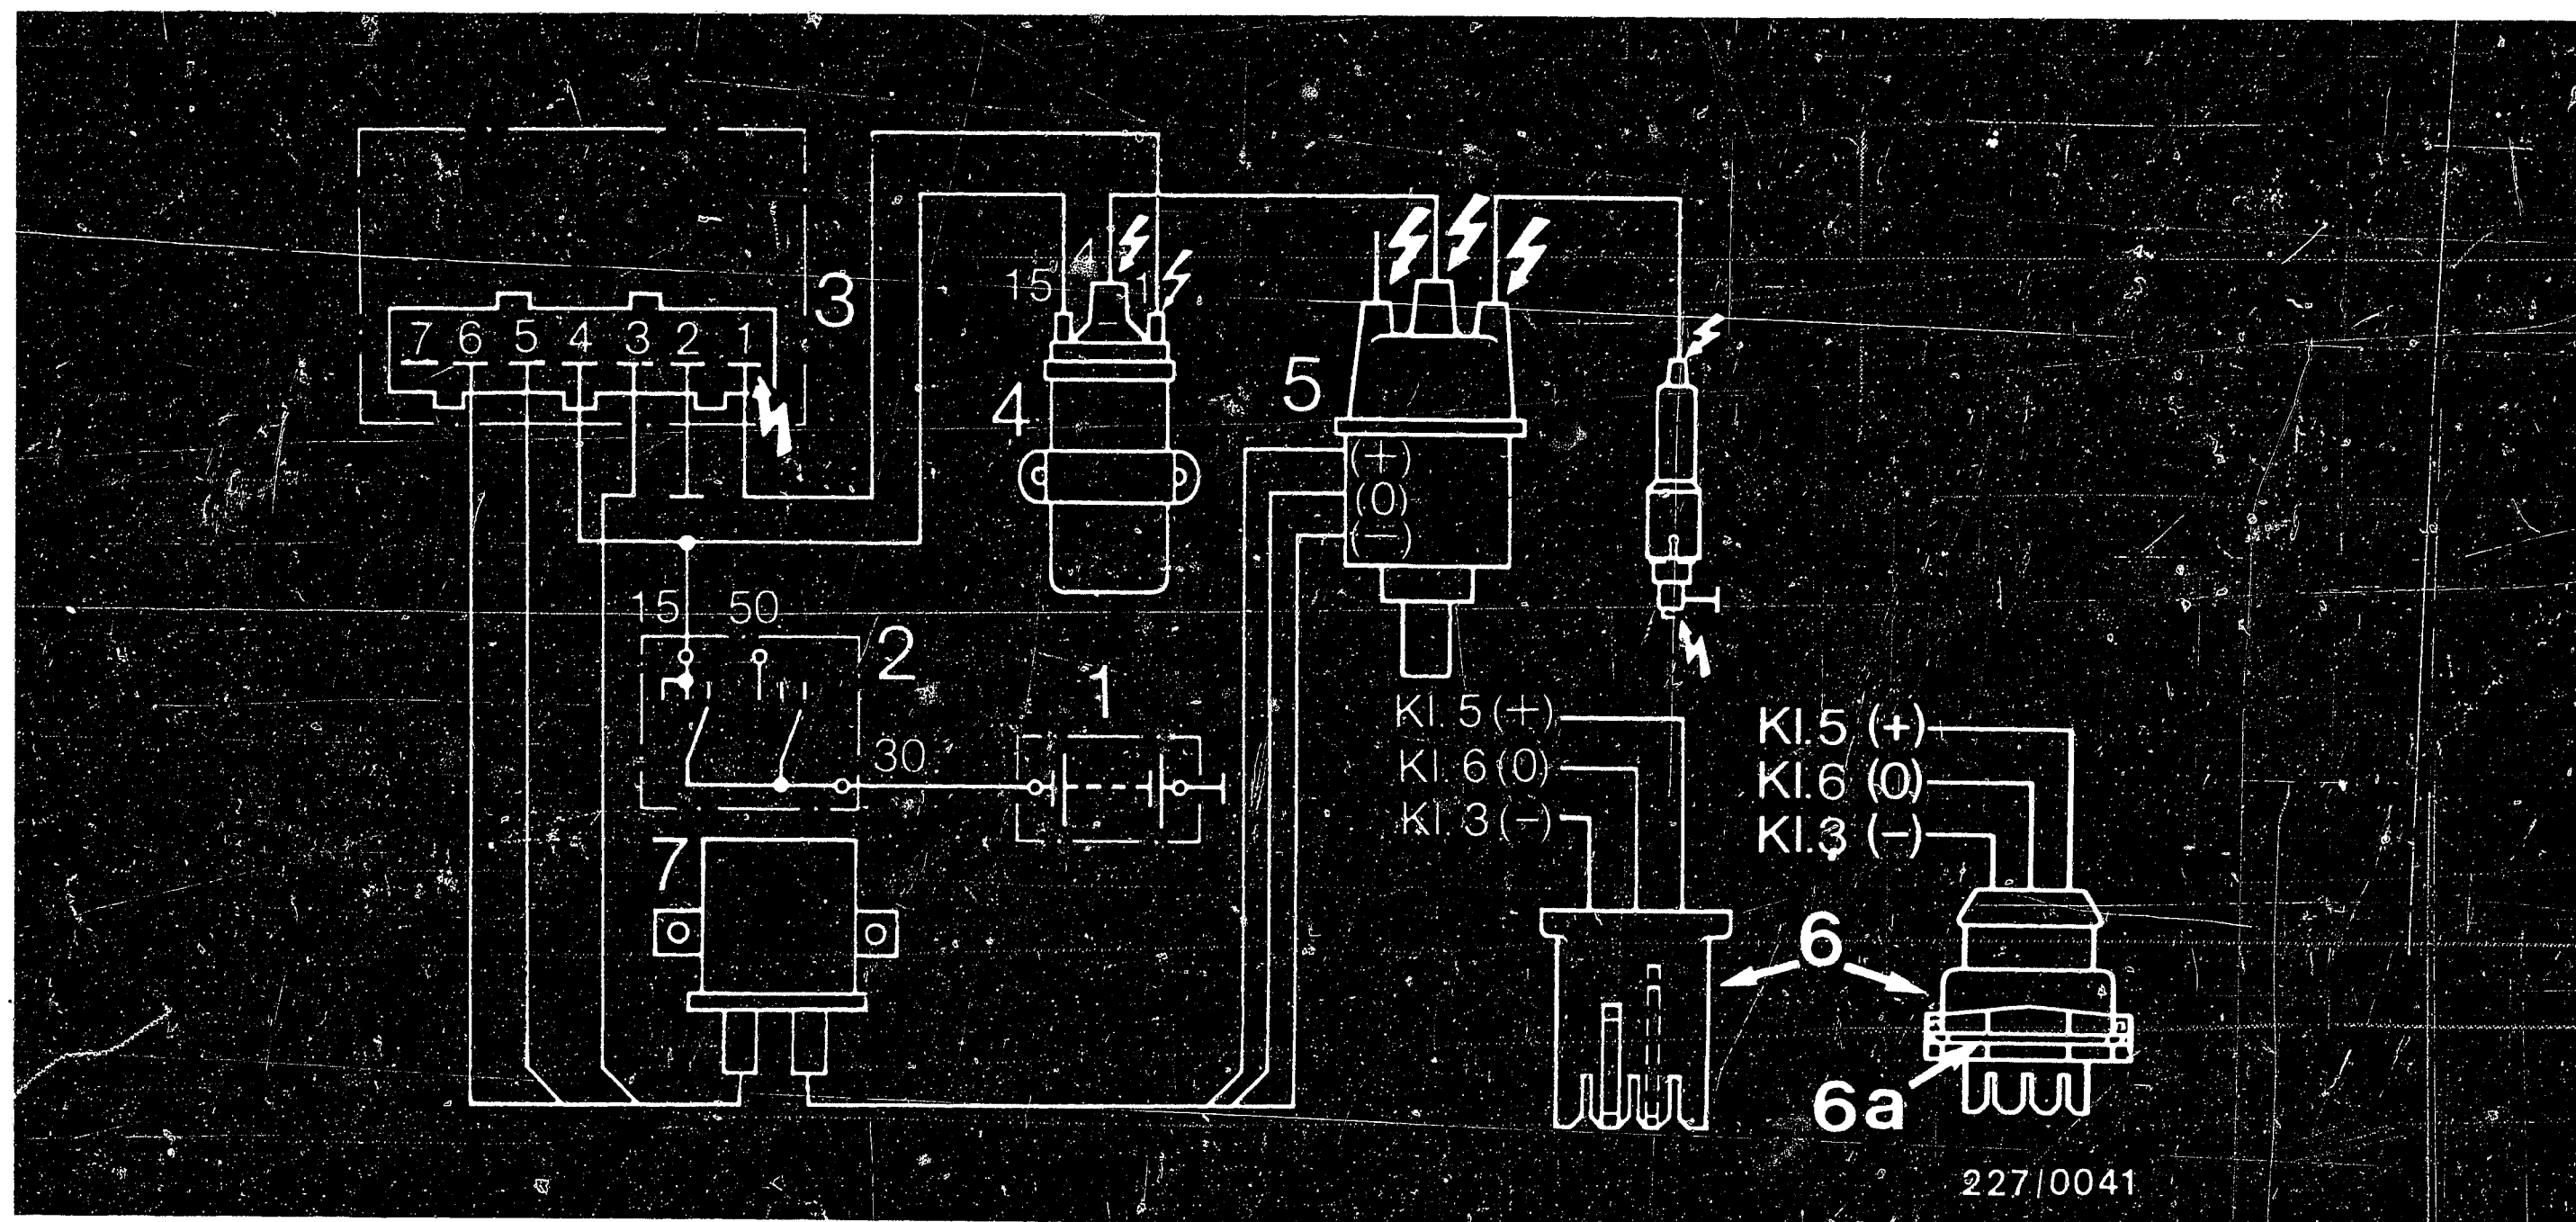
- 1 = Battery
- 2 = Ignition/starting switch
- 3 = Trigger box
- 4 = Ignition coil
- 5 = Ignition distributor

- 6 = Ignition-distributor connector
left - old version with guide lugs
right - new version
- 6a = Wire retainer
- 7 = DLS unit
- Danger arrows = Dangerous voltage

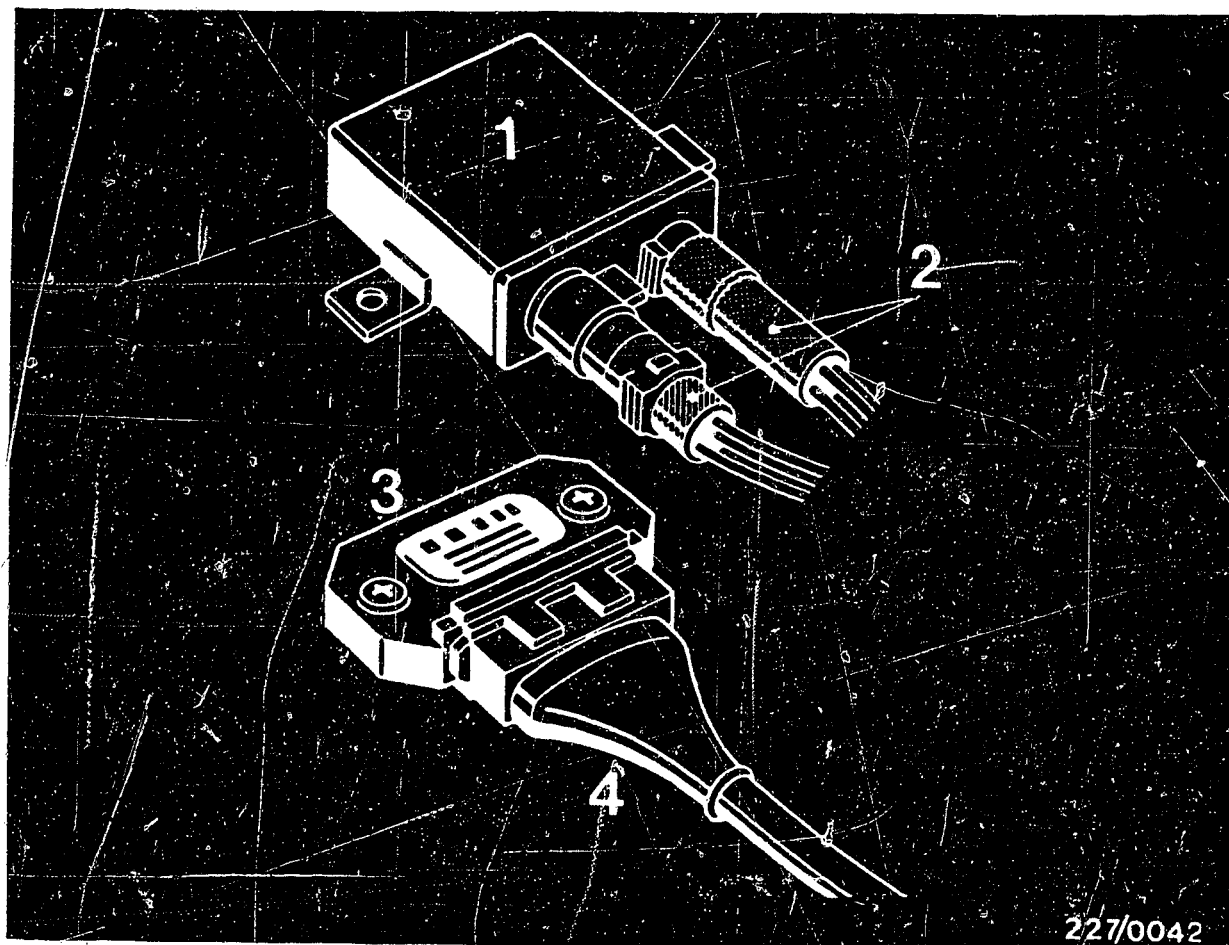
227/0042

Electrical terminal diagram
Volkswagen

- 1 = DLS unit
- 2 = DLS connector
- 3 = TI-H trigger box
- 4 = Trigger-box plug

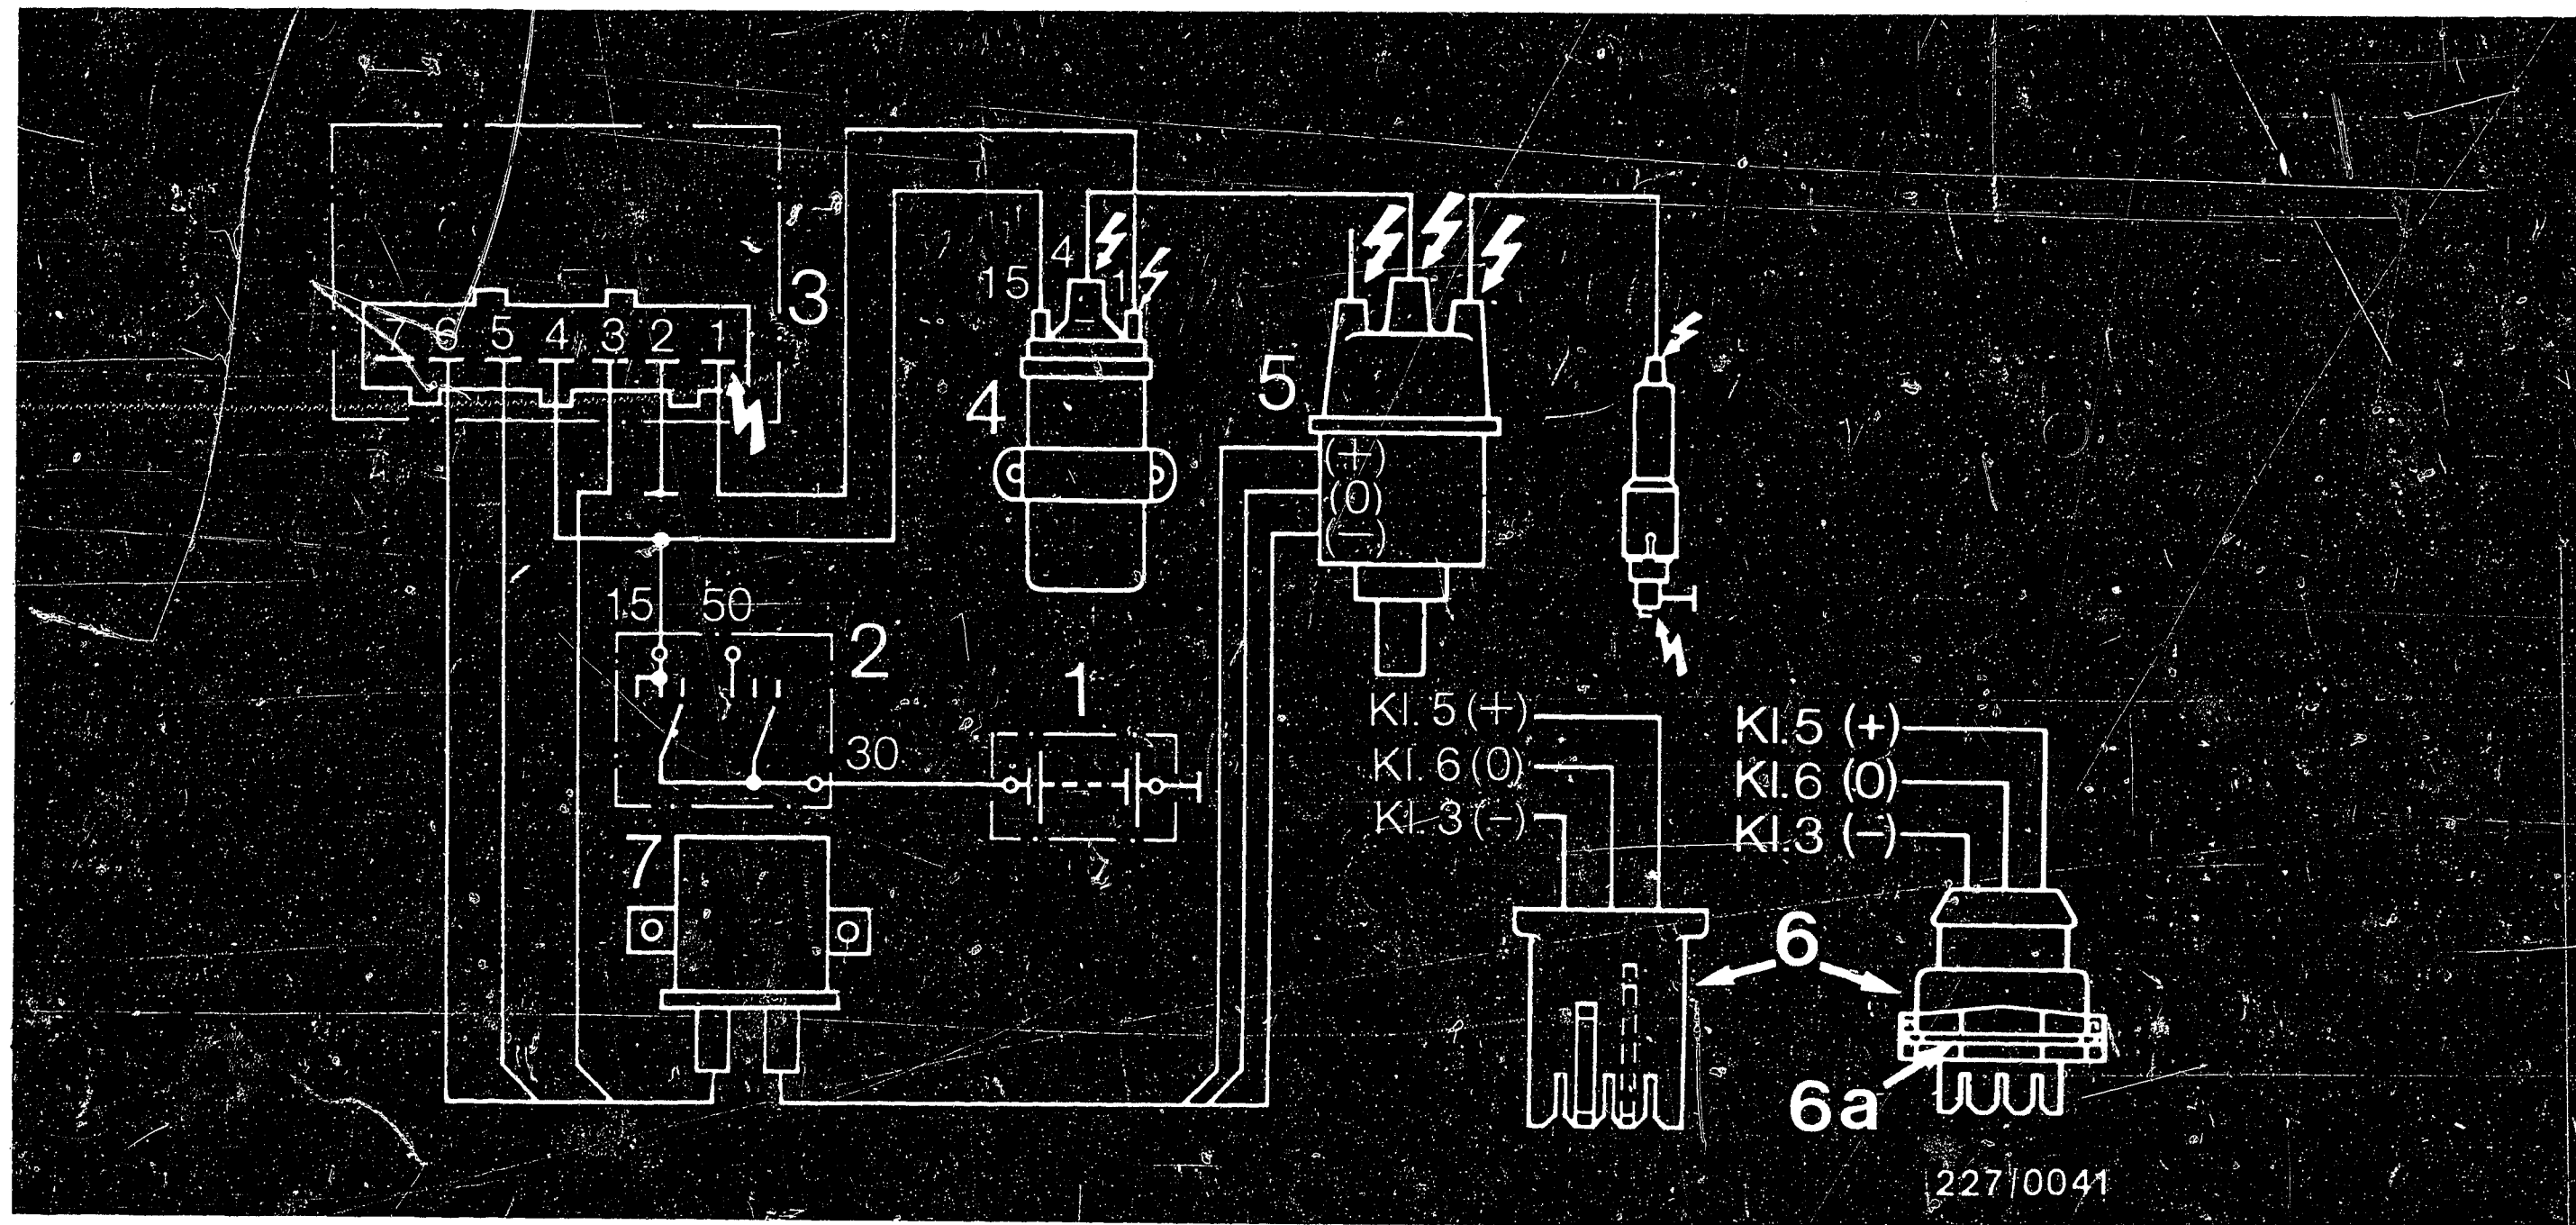
- 1 = Battery
- 2 = Ignition/starting switch
- 3 = Trigger box
- 4 = Ignition coil
- 5 = Ignition distributor

- 6 = Ignition-distributor connector
left - old version with guide lugs
right - new version
- 6a = Wire retainer
- 7 = DLS unit

The danger of accident exists, therefore, not only on the individual assemblies of the ignition system (e.g. ignition distributor, ignition coil, trigger box, ignition harness), but also on the wiring harness (e.g. tachometer connection, diagnostic plug), at plug-in connections and test equipment.

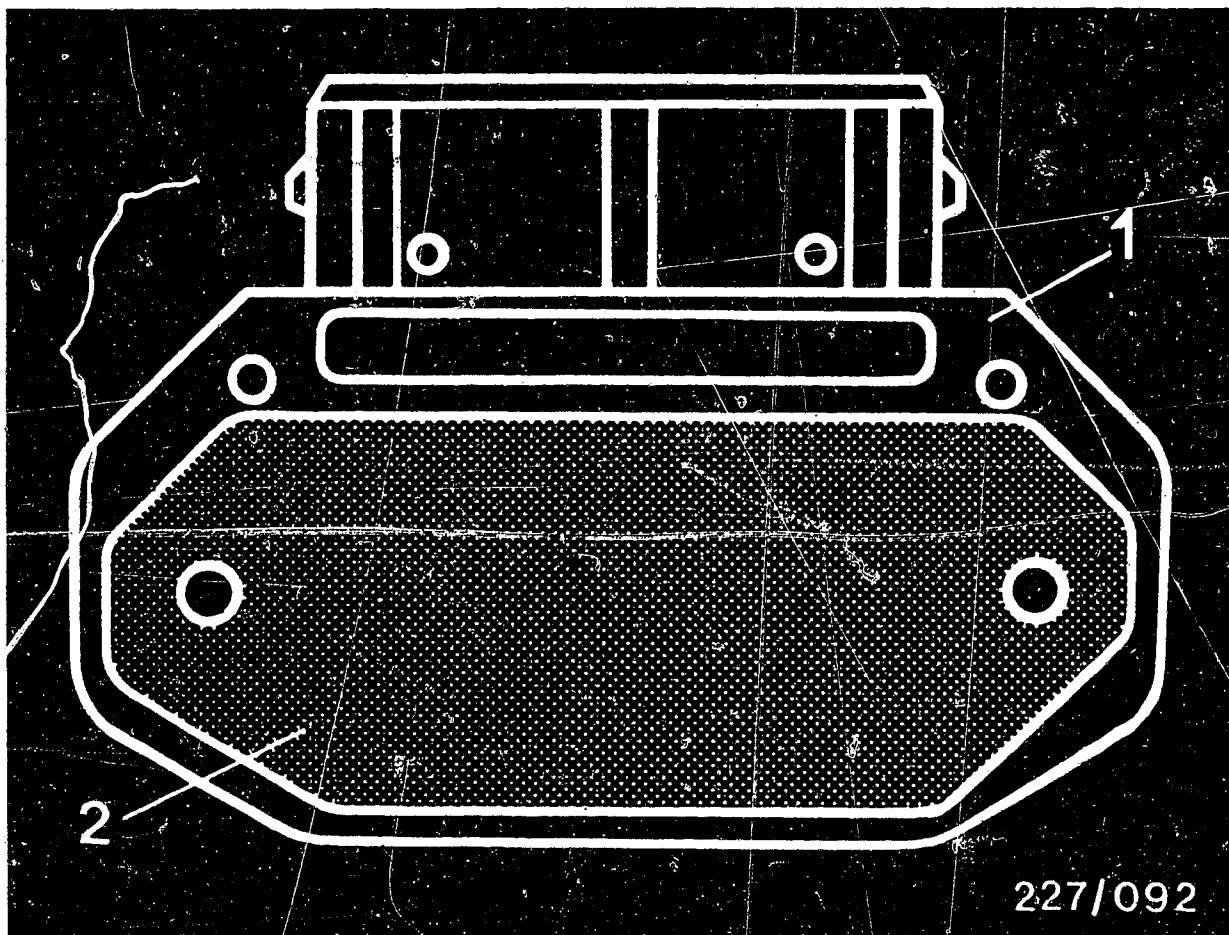
227/092

1 = Trigger box
2 = Base plate

- Before the trigger box is fitted, its base plate must be coated with thermal conduction paste. Only use an appropriate object to apply the paste (screwdriver, matchstick etc.). Thermal conduction paste is not to come into contact with painted surfaces.

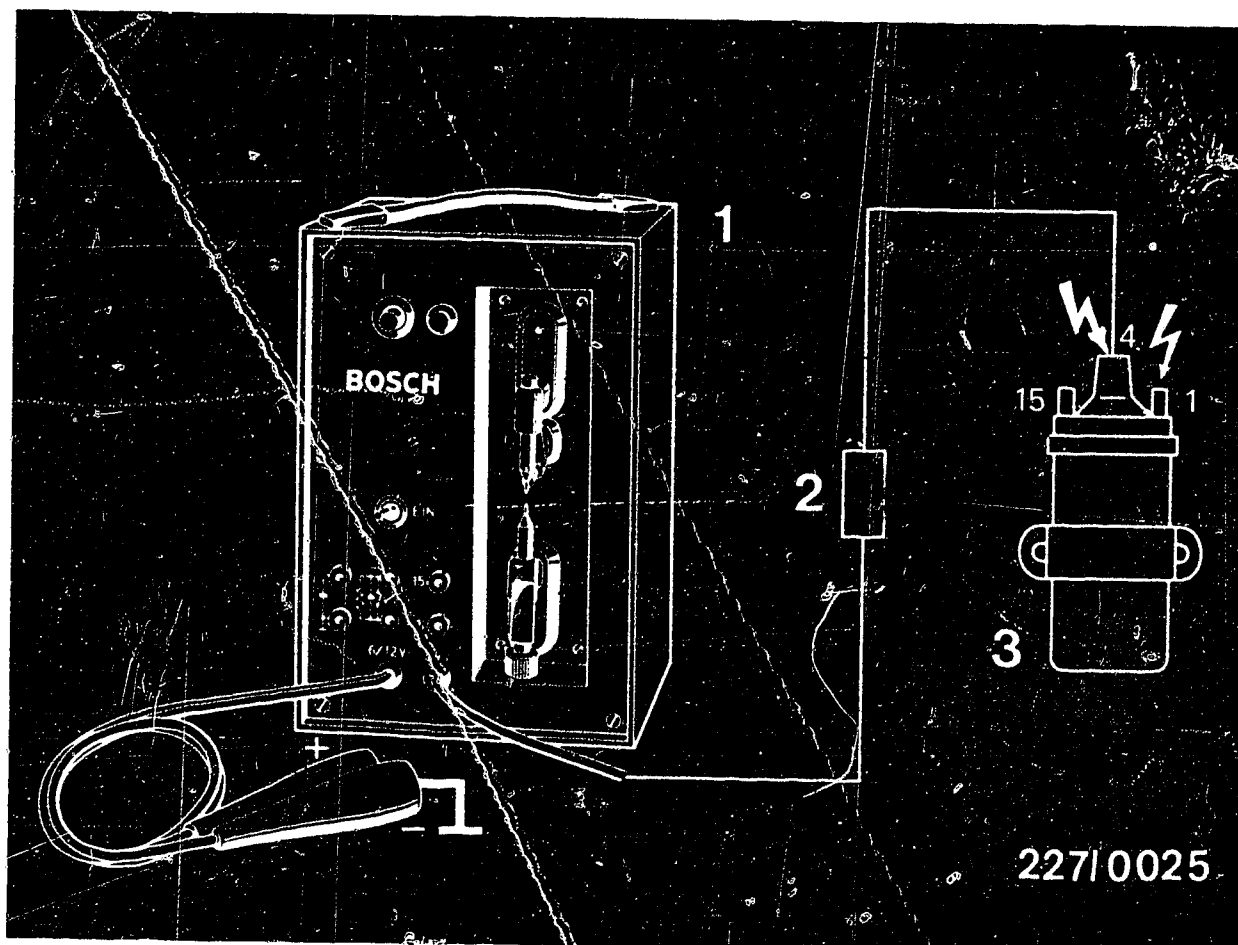
- 1 = Spark gap
- 2 = 5 kΩ sleeve-type suppressor
- 3 = Ignition coil

Danger arrows = dangerous voltages
(400 V - 25 kV)

- In order to prevent the trigger box from being irreparably damaged, when using a spark gap, an interference-suppression resistor of at least 2 kΩ must be connected between the spark gap and ignition coil terminal 4, e.g. sleeve-type suppressor (5 kΩ) 0 356 500 001.
- In the case of ignition distributors with engine-speed limitation the ignition distributor side terminal 4 must have 1 kΩ interference suppression.
Operation without interference suppression will lead to the destruction of the trigger box.

Note: Auxiliary cable must have at least 2 k Ω interference suppression, e.g. sleeve-type suppressor (5 k Ω) 0 356 500 001.

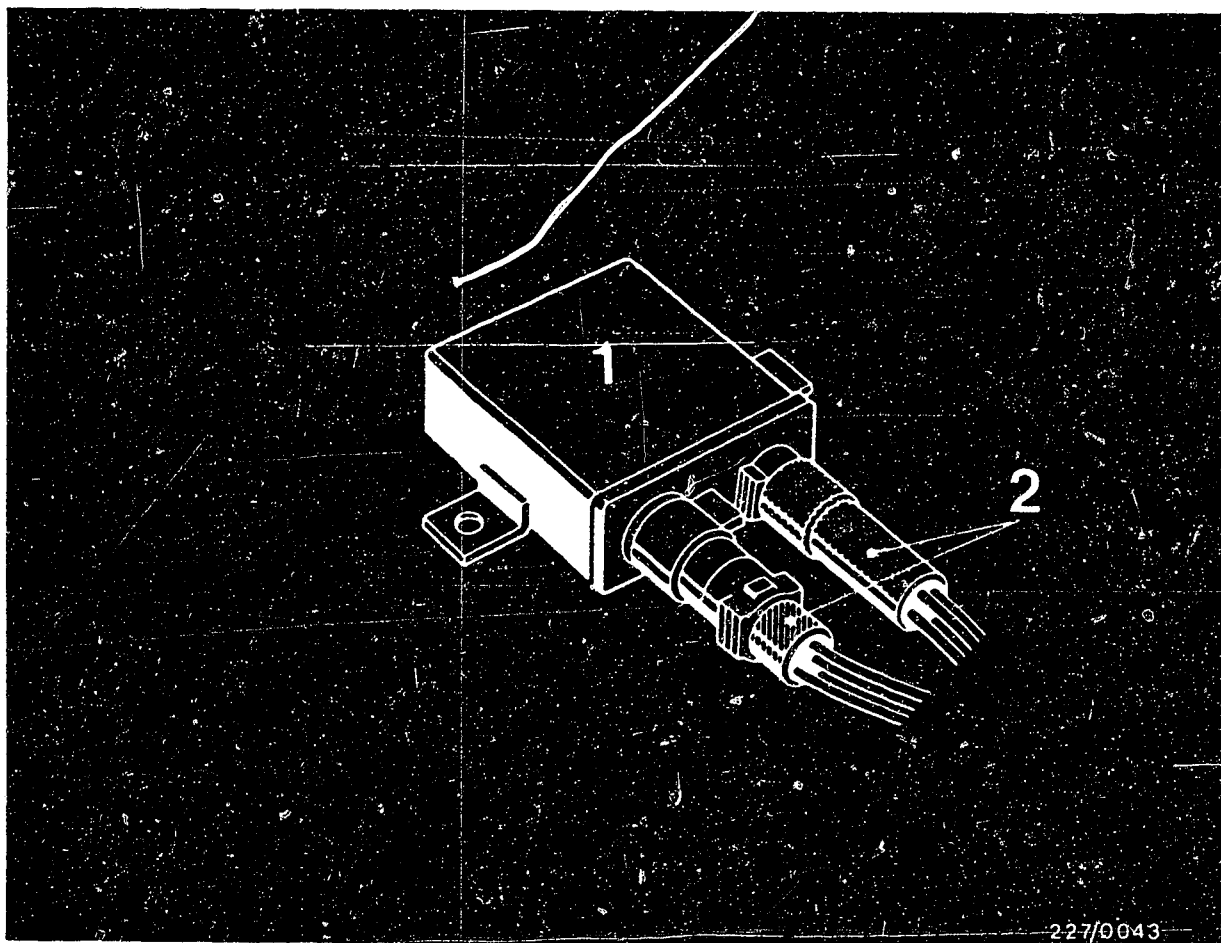
1 = DLS unit
2 = DLS connector

Visual examination: Remove both plugs from DLS unit (see illustration) and check contacts for oxidation and secure fastening (remedy defects). Plug both plugs back onto the DLS unit. If customer complaint not remedied, continue testing.

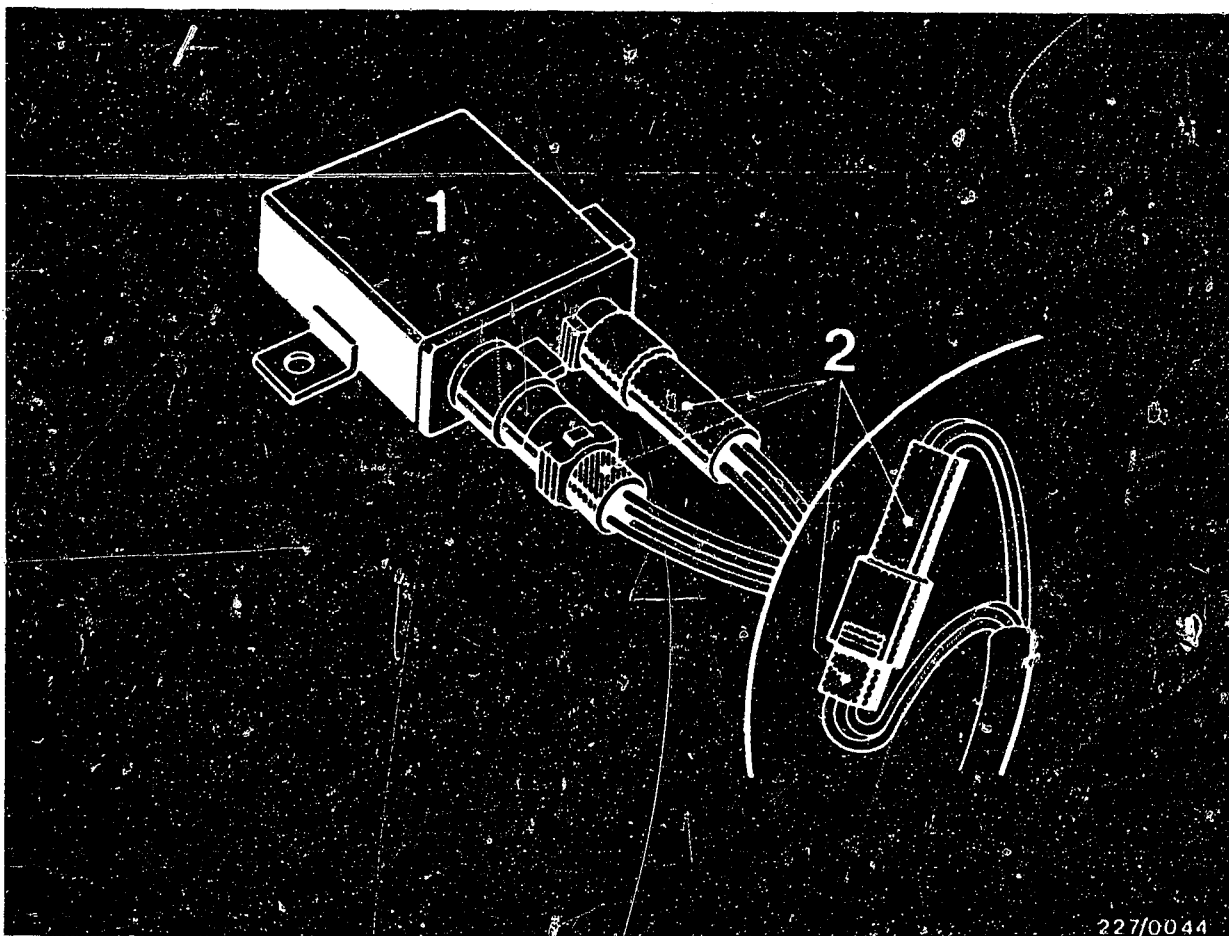
227/0044

Remove both plugs from DLS unit (2) and join together (see illustration). If customer complaint now remedied replace DLS unit. If customer complaint not remedied, continue testing.

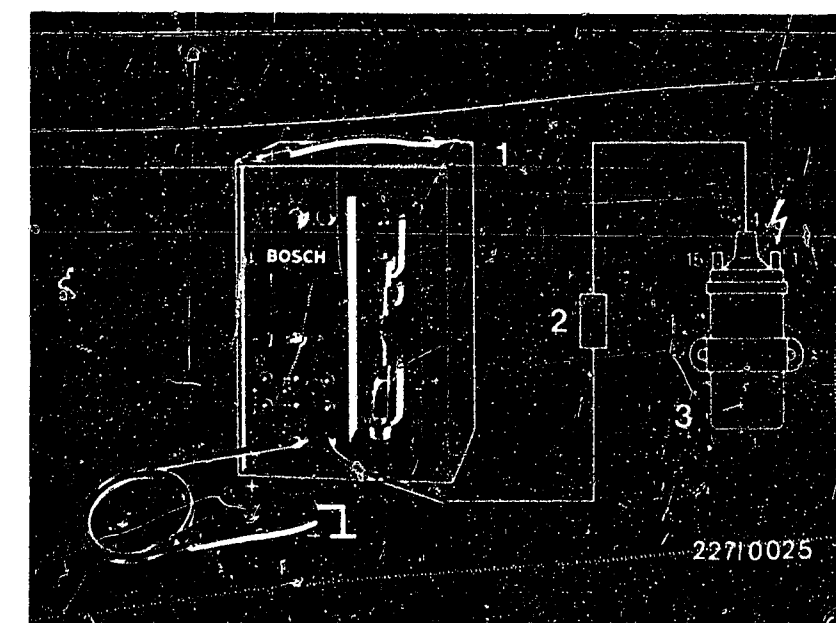
1 = Spark gap

2 = 5 k Ω sleeve-type suppressor

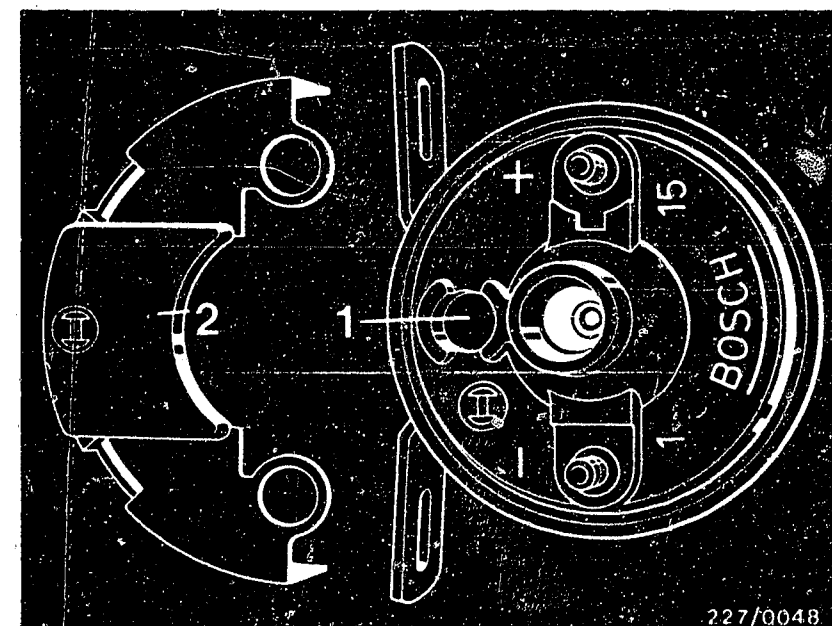
1 = Plug
2 = Protective cap

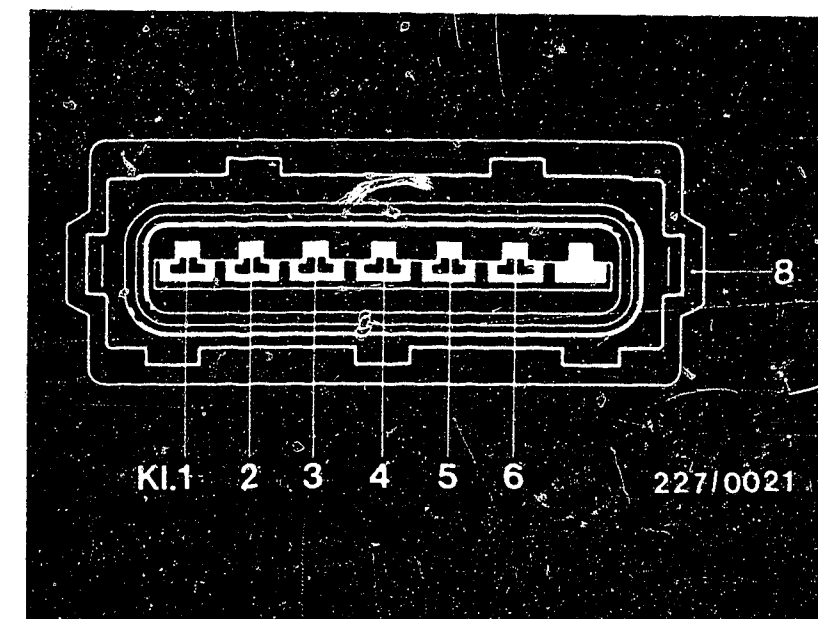
1 = Trigger-box plug

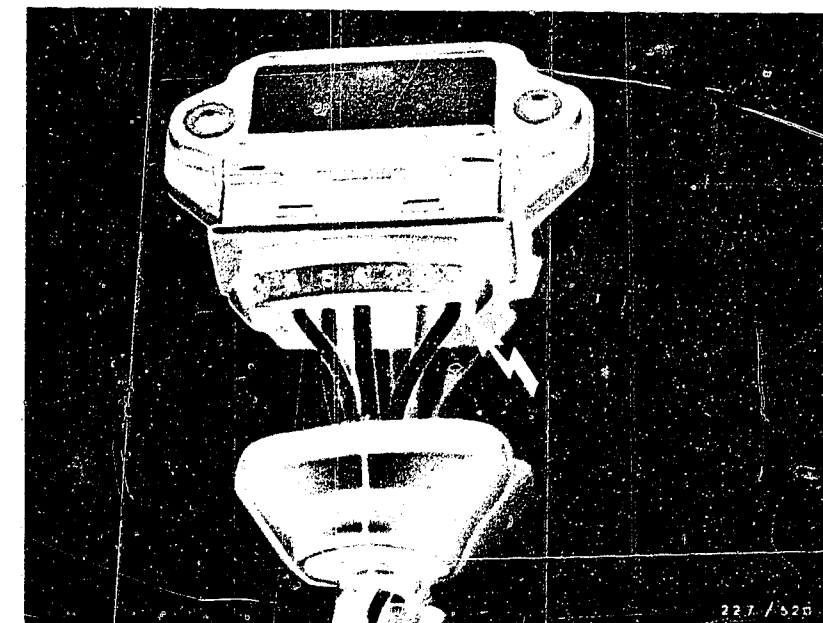
Trigger box with connector

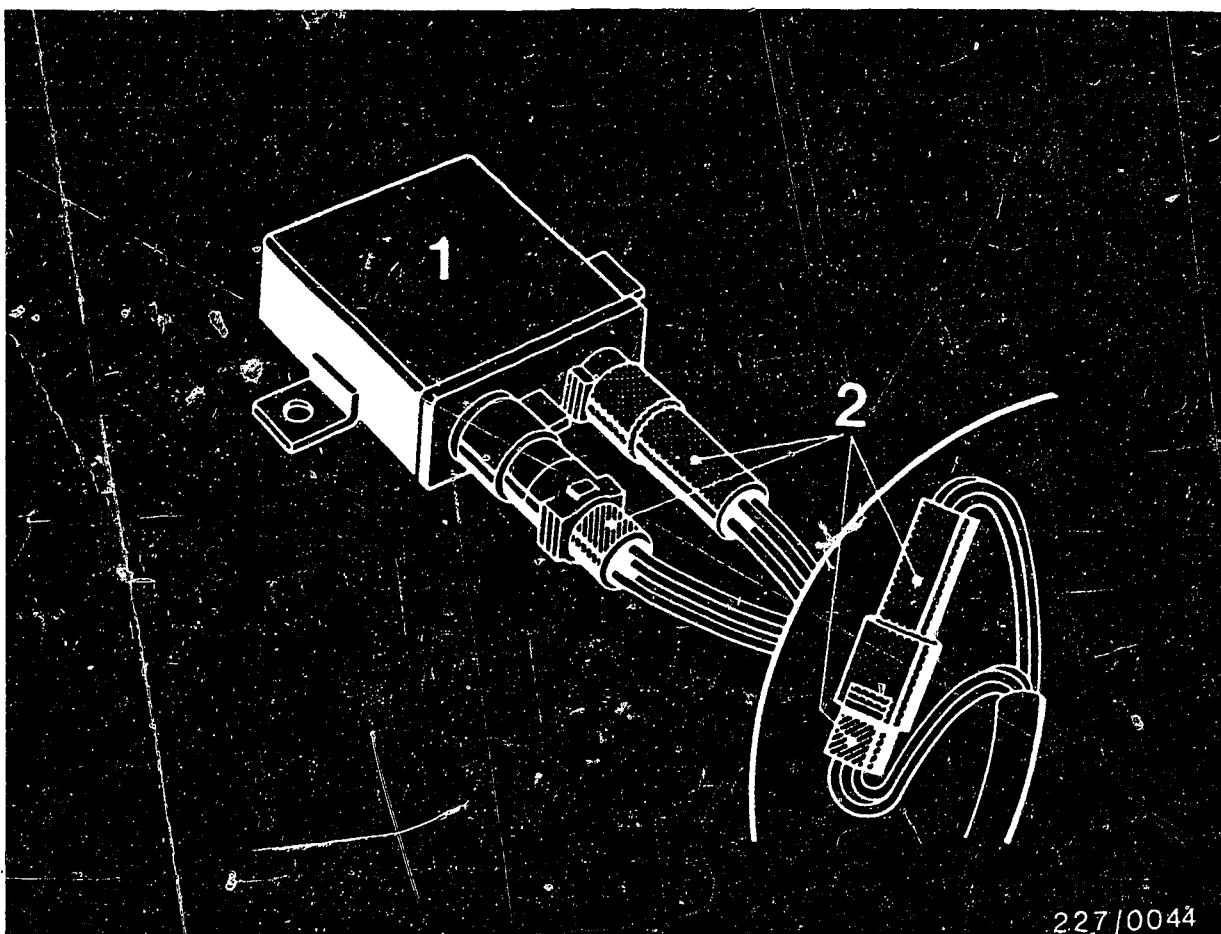
227/0044

1 = DLS unit
2 = DLS connector

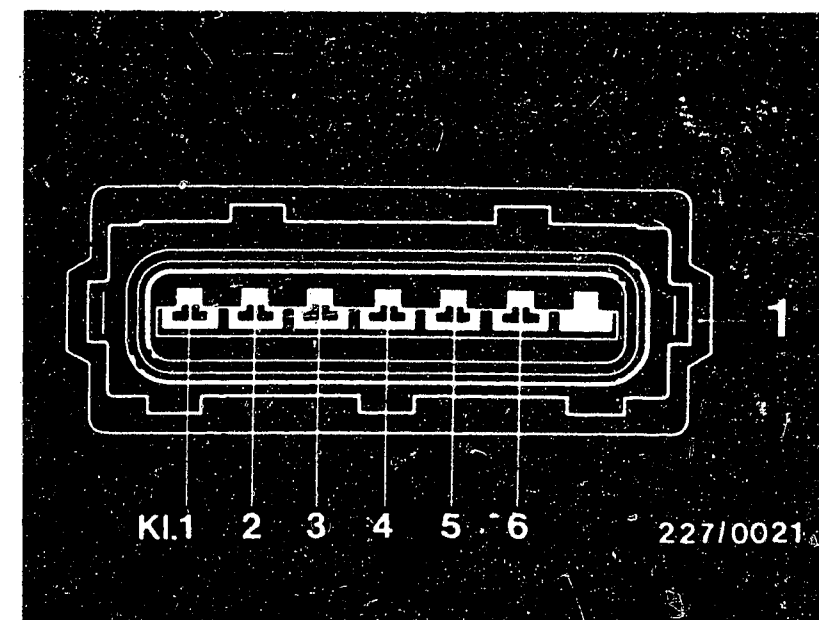
1 = Trigger-box plug

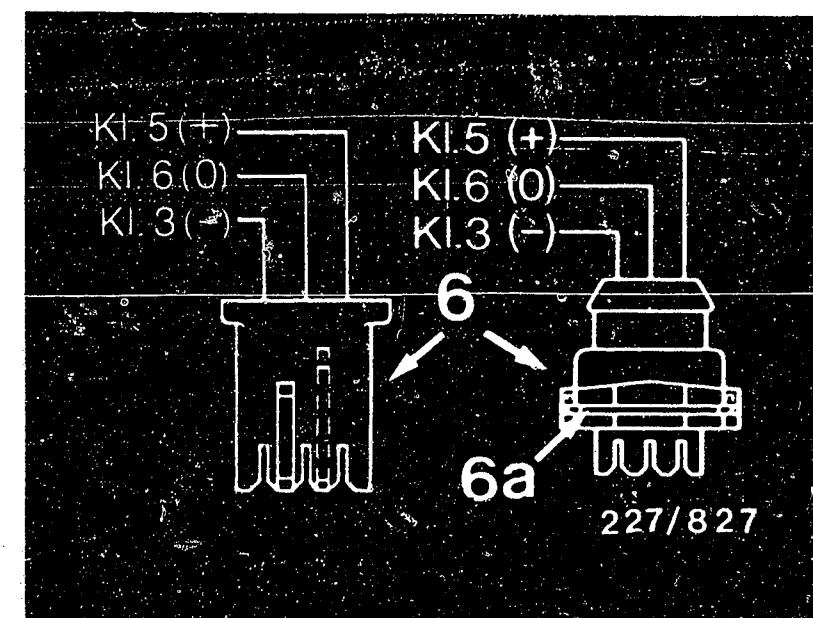
6 = Ignition-distributor plug
Left - old version with
guide lugs
right - new version
6a = Wire retainer

1 = Trigger-box plug

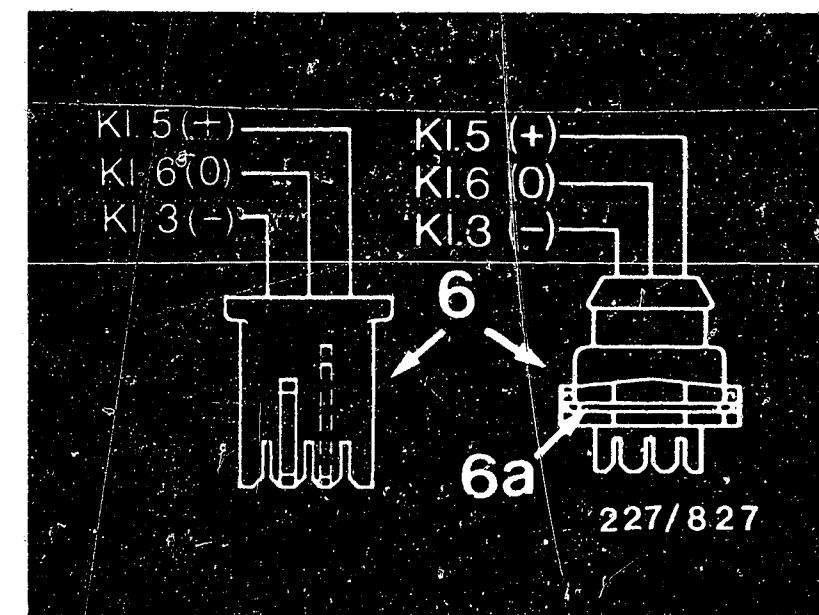
6 = Ignition-distributor plug
left - old version with
guide lugs,
right - new version
6a = Wire retainer

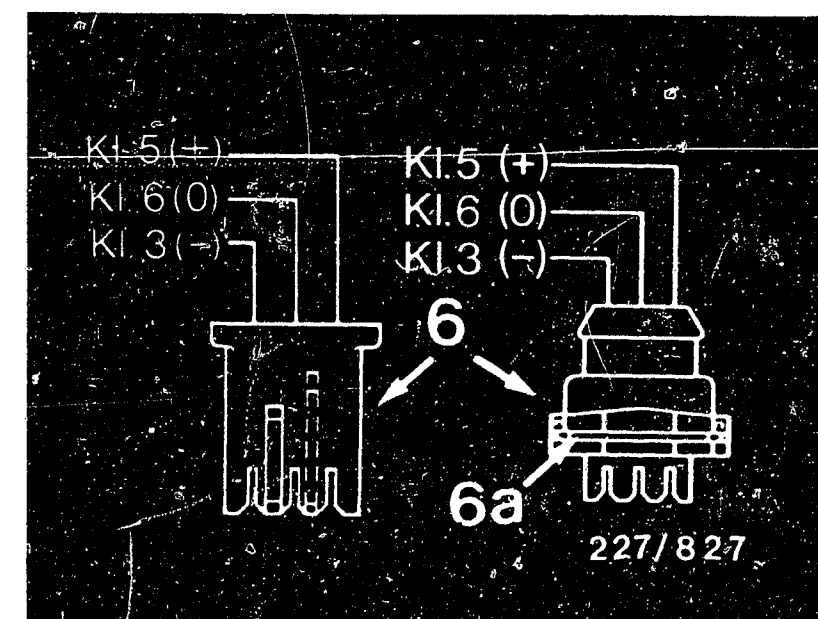
6 = Ignition-distributor plug
left - old version with
guide lugs,
right - new version
6a = Wire retainer

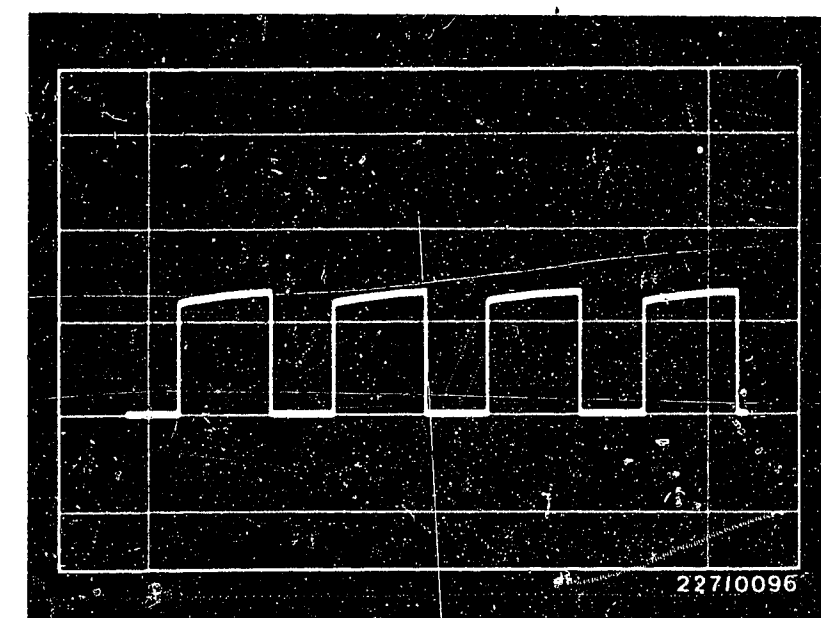
Rectangular pulse

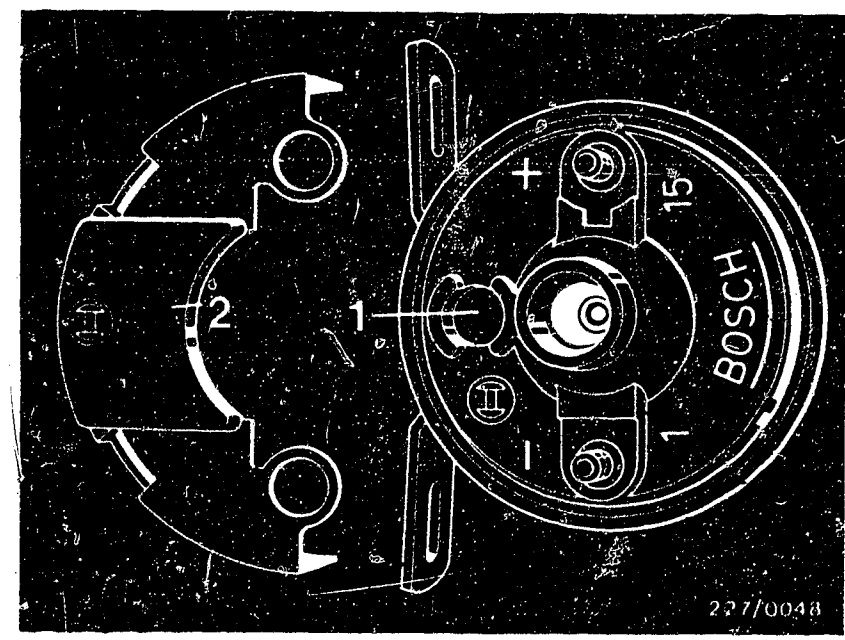
1. If plug not present/sealing compound has escaped, then replace trigger box and ignition coil.
2. If resistance values not correct, then replace ignition coil.

1 = Plug
2 = Protective cap

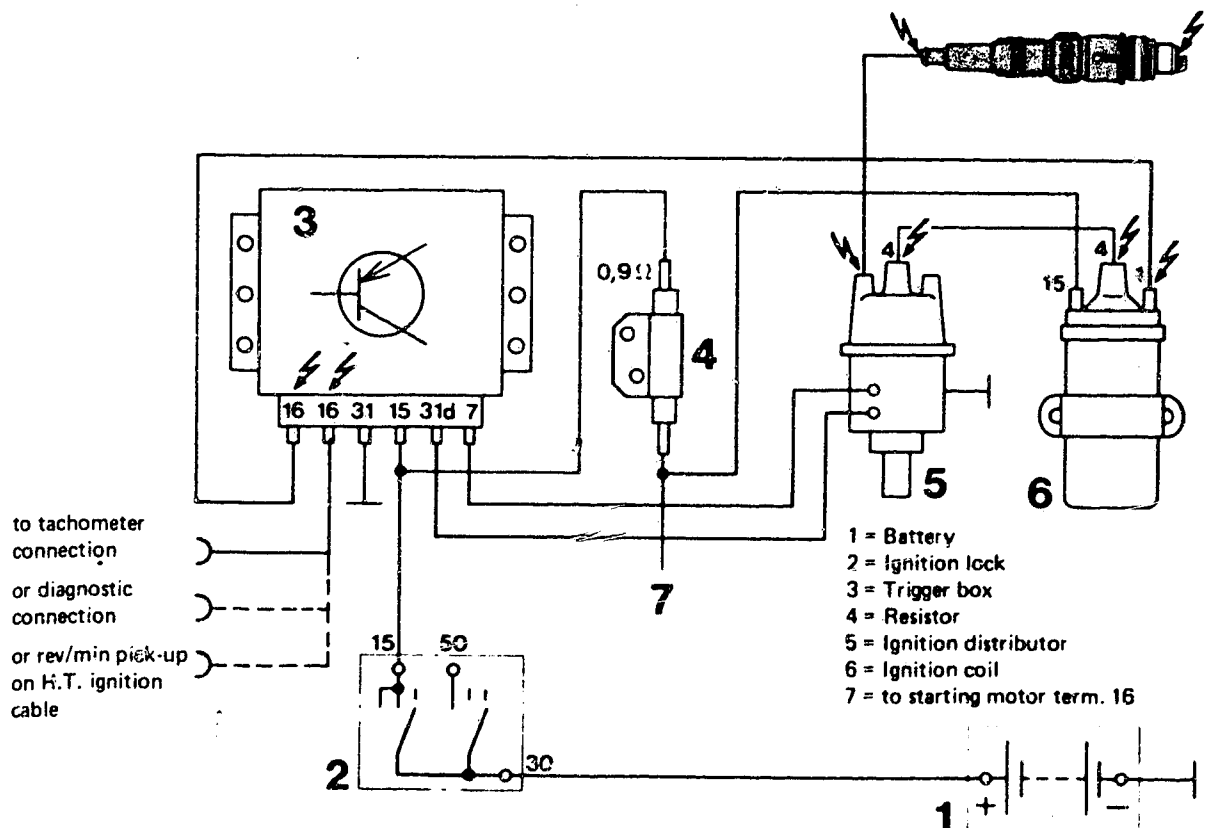
Terminal diagram

Below is a typical terminal diagram of a semi-conductor ignition system, the danger points are marked with red high-voltage arrows. We would point out that all semi-conductor ignition systems, even the older ones, are to be regarded as dangerous in the sense as defined by this bulletin.

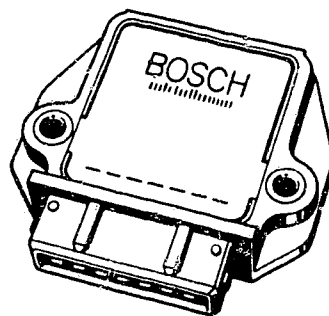
Fig. 1

Apart from the well-known TCI trigger boxes 0 227 100 0.., trigger boxes of hybrid construction have been fitted as standard since 9.78 (Fig. 1).

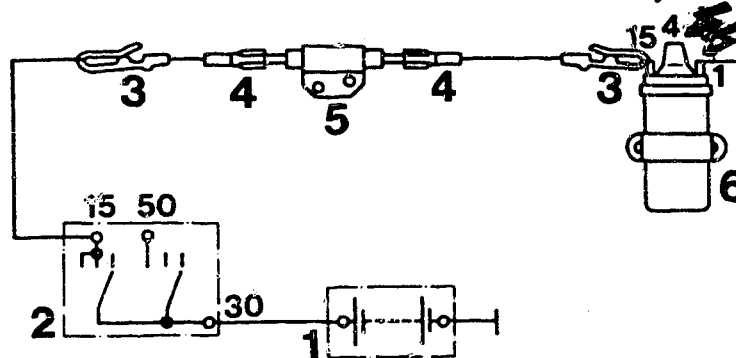
- 1 = Battery
- 2 = Ignition switch
- 3 = Clips

- 4 = Blade receptacle
- 5 = Ballast resistor
- 6 = Ignition coil

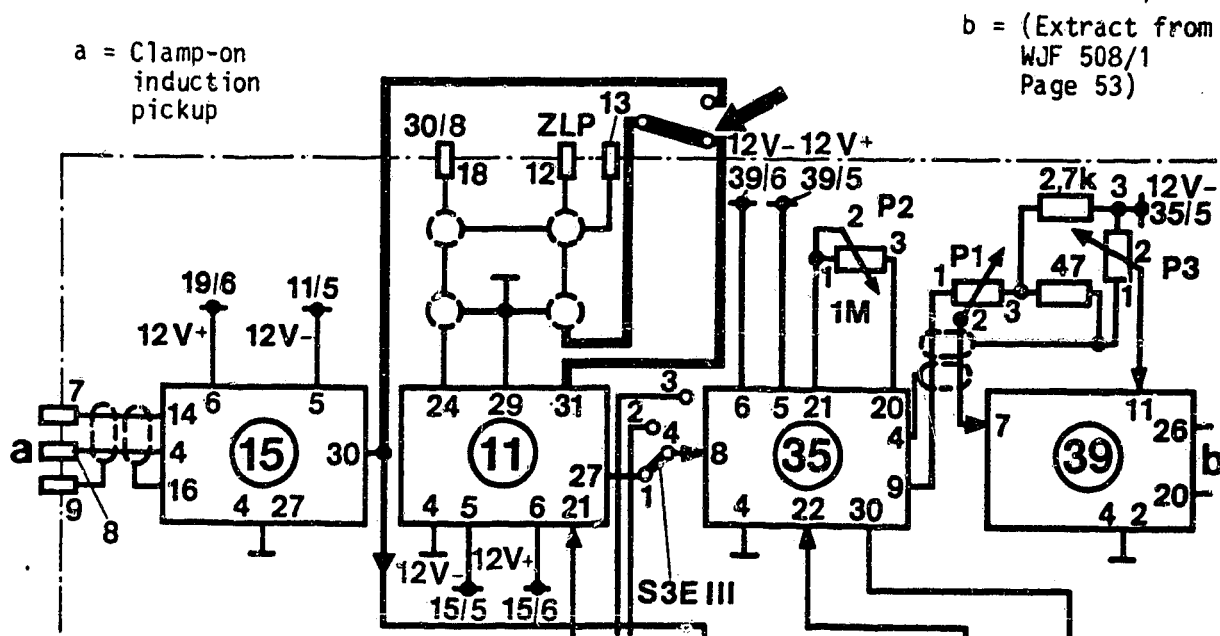
Remove the line of the ZLP* from pin 31 of printed board 11 (coupling stage) and connect to pin 30 of printed board 15 (pulse shaper stage) via a switch with change-over contact (e.g. 0 341 500 803). In addition, a new line must be connected from pin 31 of printed board 11 to the other contact of the switch with change-over contact. Arrow points to switch with change-over contact.
